LAKE SOMERSET DAM

PHASE I INSPECTION REPORT  
NATIONAL DAM INSPECTION PROGRAM

AUGUST 1979

Lake Somerset Dam: NDI I.D. No. PA-00229

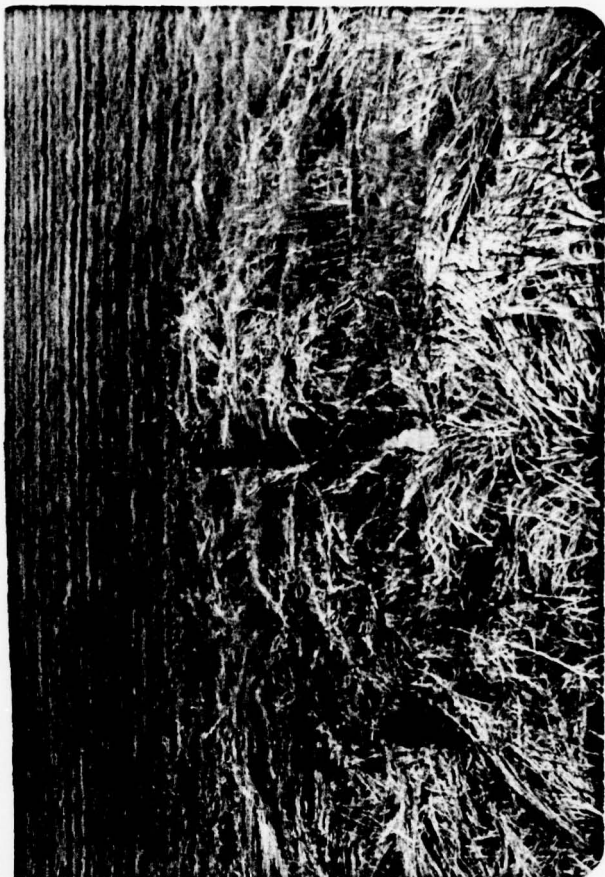
PHOTOGRAPH 4 View of a typical wet spot found along the downstream embankment toe to the right of the outlet conduit.

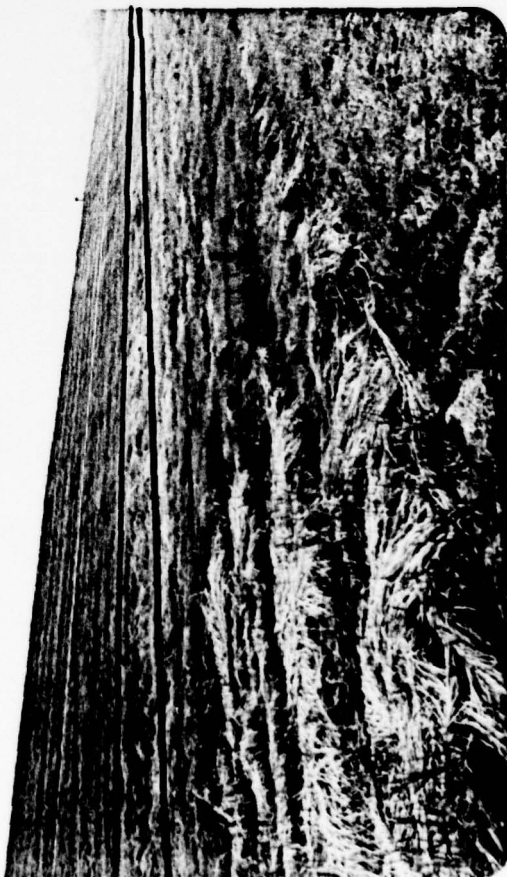
Observations made during the visual inspection suggest that the embankment may be structurally unsafe as extensive areas of seepage were noted on the downstream embankment slope and immediately below the toe area to the right of the outlet conduit. Seepage conditions became evident shortly after reservoir filling and have persisted in spite of the installation of a remedial sand drain system near the toe.

a. Safety. Visual observations indicate that, although the facility is well maintained, the embankment suffers from a serious seepage condition along the downstream slope and toe to the right of the outlet conduit. Field measurements indicate that the seepage surfaces along the downstream slope approximately 6 feet below the normal pool level. No sloughing or slumping is evident along the embankment, but, the condition is of such a nature that the facility is considered unsafe, non-emergency.

PHOTOGRAPH 3 View of the downstream embankment face to the right of the outlet conduit where seepage was observed. Two black lines attached to the photograph represent the base of the slope (bottom line) and top of observed seepage (top line), respectively.

a. Retain the services of a professional engineer, experienced in the design and construction of earth dams, to study the embankment and assess the effects of the seepage conditions on embankment stability under all possible operating conditions (including earthquake loading) and make remedial recommendations as deemed necessary. The study should include (but should not be limited to) drilling, soils testing to establish actual engineering properties, instrumentation, and an assessment of the effects of reservoir drawdown to a safe operating level which should be maintained until remedial studies and/or repairs are completed.

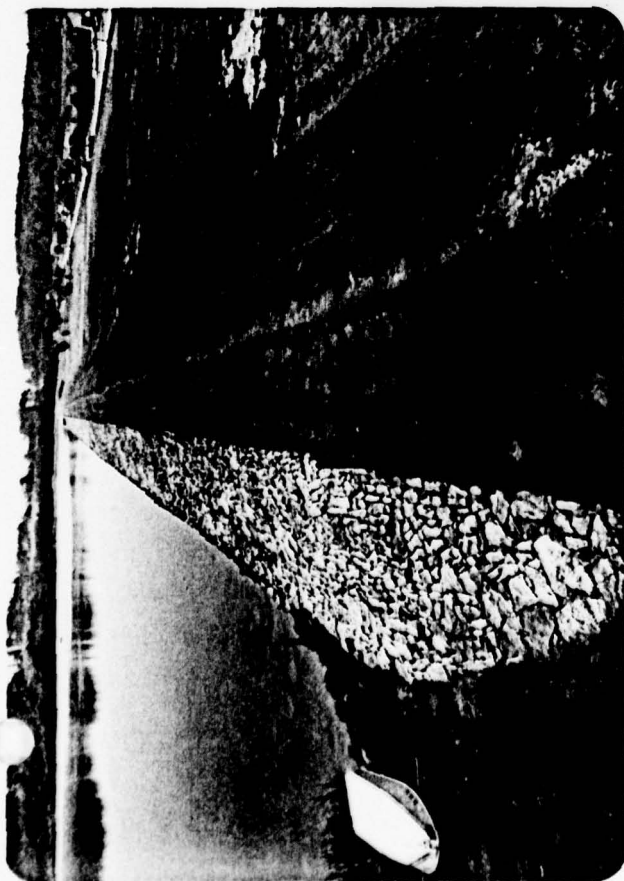
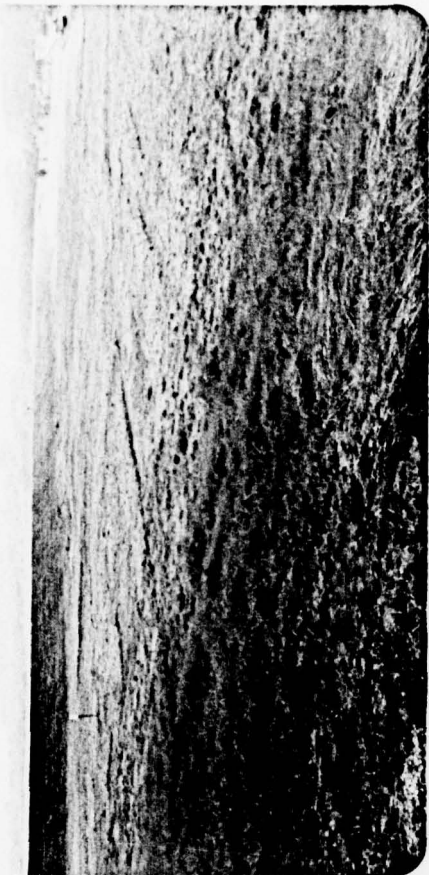
b. Embankment. The field inspection indicated that the embankment is well maintained (see Photographs 1 and 2), but, is considered to be in poor condition due to substantial seepage through its downstream face and in that area immediately downstream of the toe (see Photographs 3 and 4). An approximate mapping of the observed seepage is shown on Figure 1 and Photograph 3. As indicated, seepage through the embankment was evident along a line that was only about 6 feet below the pool level (normal pool) at the time of inspection. Discharge from the drains installed after reservoir filling and concentrated surface flow, all of which empty into the channel downstream of the outlet conduit, indicate clear seepage is in excess of 10 gallons per minute. No signs of instability (sloughing, and/or slumping of embankment slopes) were observed while the measured features generally conform to the design drawings.

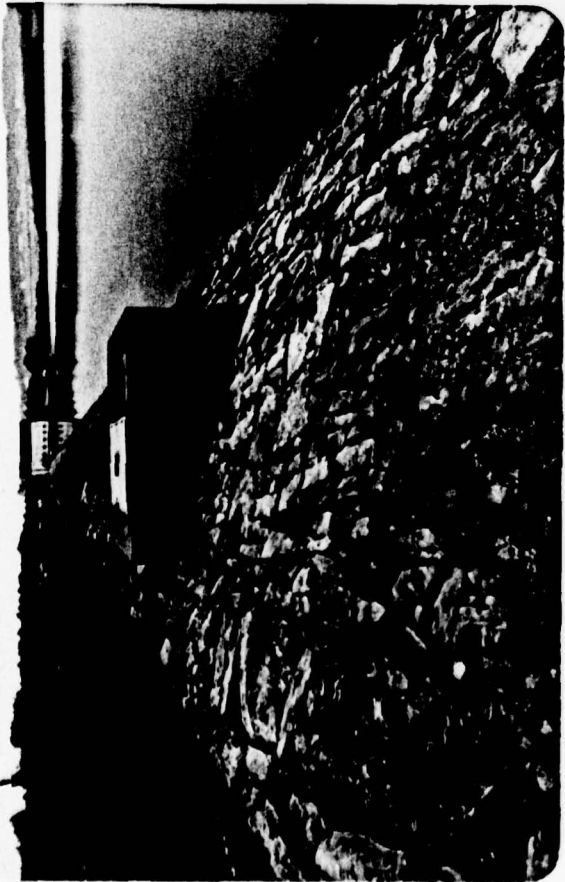
PHOTOGRAPH 5 View, looking northwest toward the right abutment, of the embankment crest and upstream face. The buildings in the background house the regional field office of the Pennsylvania Fish Commission.

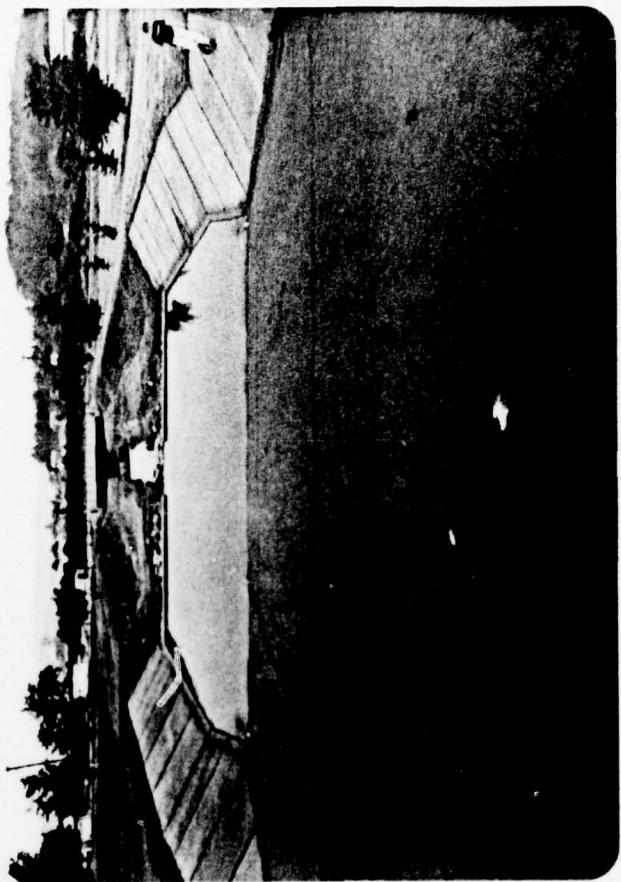
PHOTOGRAPH 12 View looking downstream from the spillway crest.

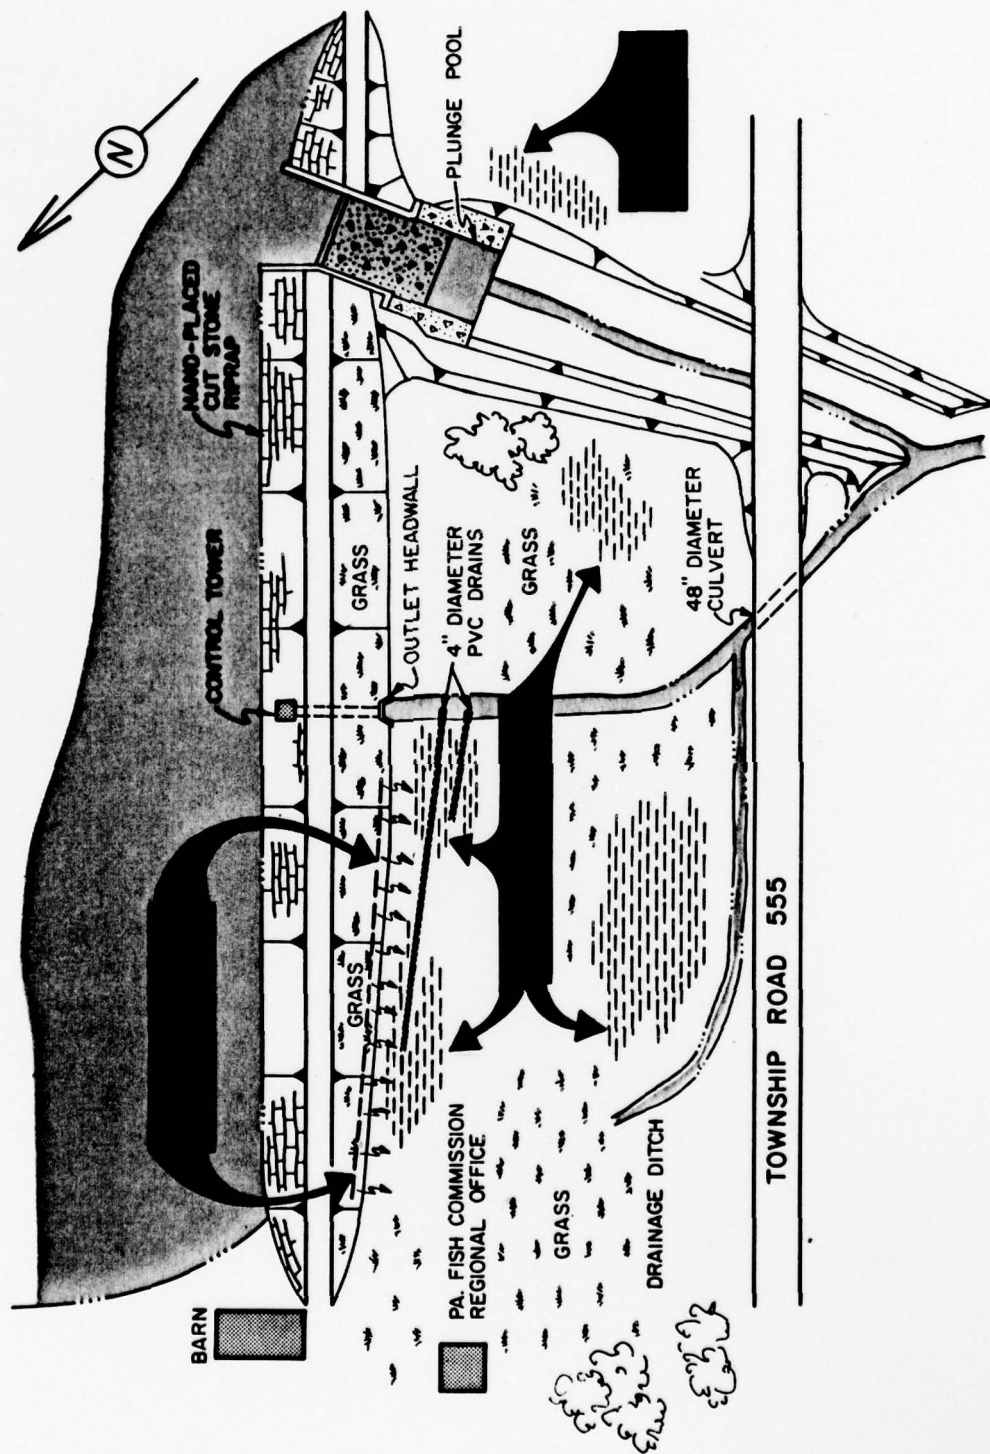
FIGURE 1 - LAKE SOMERSET DAM  
GENERAL PLAN : FIELD INSPECTION NOTES

ITEM	OBSERVATIONS AND/OR REMARKS	NDI# PA - 229
DAMP AREAS IRREGULAR VEGETATION (LUSH OR DEAD PLANTS)	Extensive areas of saturation were noted in the flat area beyond the downstream embankment toe (see Figure 1, Appendix F).	
ANY NOTICEABLE SEEPAGE	Substantial seepage was observed to be issuing through the downstream face of the embankment and through the flat area immediately downstream from the embankment toe. Wet or damp areas were found along the downstream face as high as elevations which were only 6' below the normal pool level. See Appendix F, Figure 1 for a field sketch which outlines the areas of concern.	
STAFF GAGE AND RECORDER	None.	
DRAINS	Two drains have been installed along the downstream toe to transport some of the seepage water to the outlet channel. Estimated discharge at the time of inspection was in excess of about 10 gallons per minute.

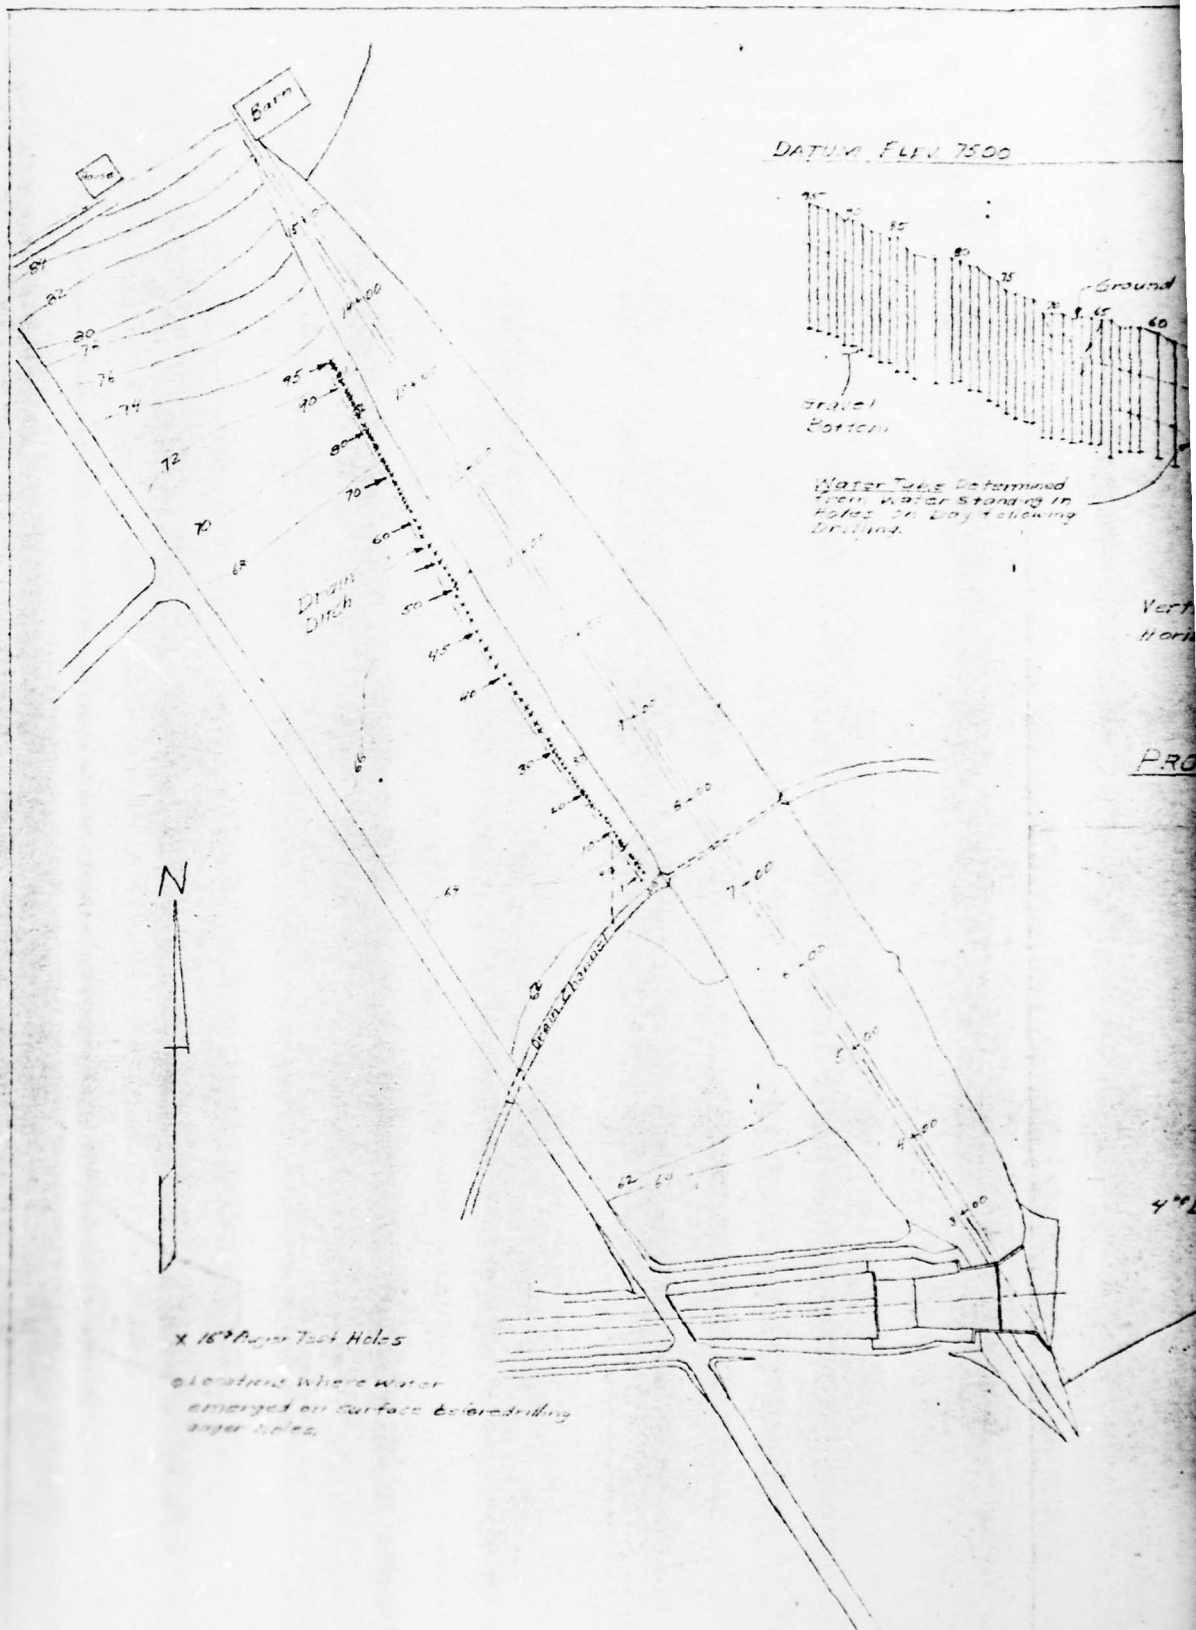
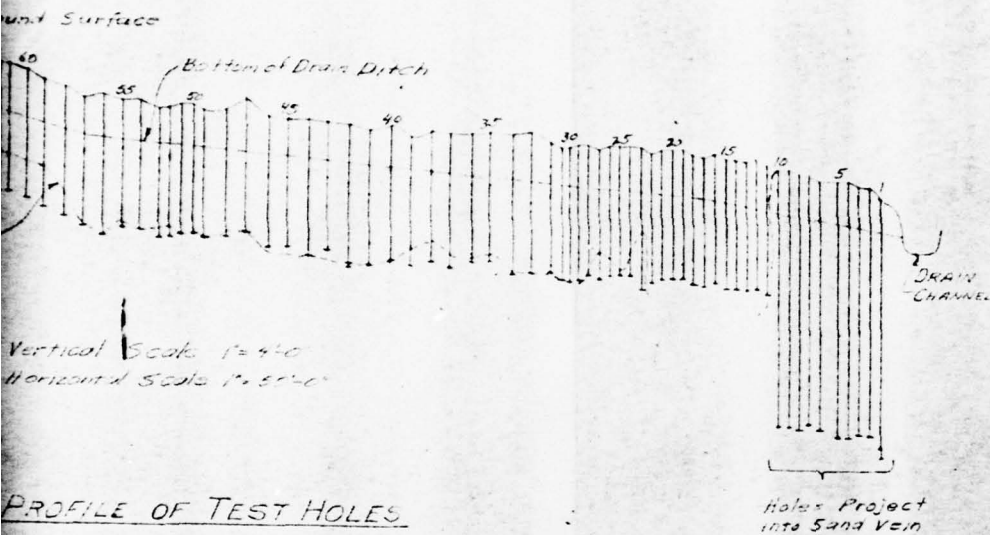
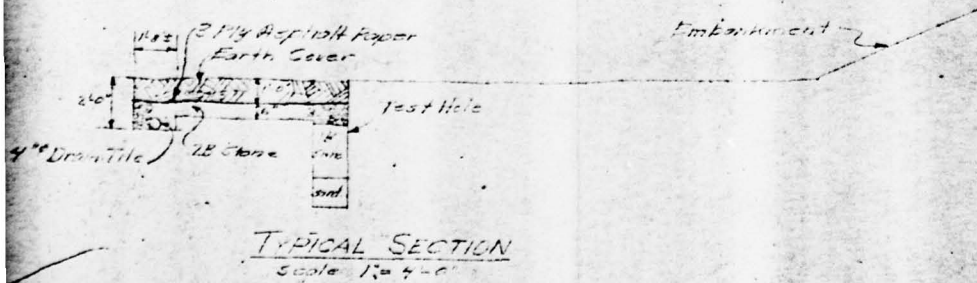
FIGURE 7

Ninety-five, 16-inch diameter, 5 and/or 10-foot deep test holes (sand drains) were installed after the dye test program to further assess the seepage and provide positive drainage of the area (see Figure 7). Details of the drilling and remedial work are contained in PFC files. Conditions observed during the field inspection indicate the drainage system is inadequate or ineffective.
